Thermal infrared analysis for buildings integrating with 5D BIM

End-to-end service to detect insulation leaks of roof

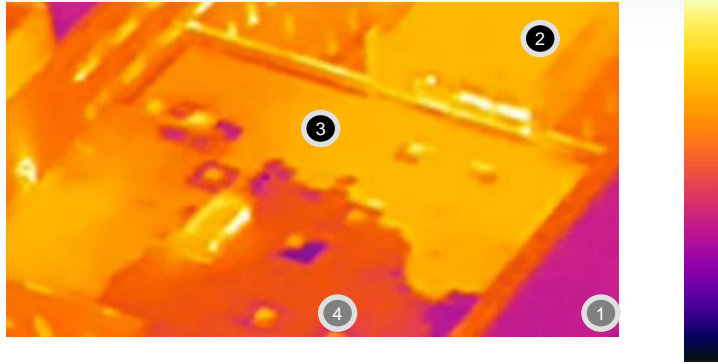
Qualitative thermal infrared image (overview with relative differences)

- ① ④ Roof is well insulated because it is at a temperature close to the ambient temperature ✓
- ② Heat losses because roof is at higher temperature (delta = XX degrees) than other roofs. Melting pattern confirm the higher temperature. The loss might be due to the design rather than bad construction work. ⚠
- ③ Heat losses because part of roof is at higher temperature (delta xx degrees) than part 4 of the roof and other roofs. The melting pattern confirms the heat losses at part 3 because of very similar profiles. ⚠

- ⑤ Metallic ventilation tubes appear to be at a very low temperature. However this is due to the reflection of the clouds at 0 C (altitude 2600 ft). ✓
