Thermal infrared analysis for buildings integrating with 5D BIM

End-to-end service to detect insulation leaks of roof

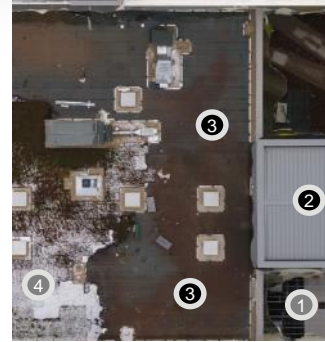
Visual mapping for cross referencing

- ① ④ Roof is well insulated because it is at a temperature close to the ambient temperature ✓
- ② Heat losses because roof is at higher temperature (delta = XX degrees) than other roofs. Melting pattern confirm the higher temperature. The loss might be due to the design rather than bad construction work. ⚠
- ③ Heat losses because part of roof is at higher temperature (delta xx degrees) than part 4 of the roof and other roofs. The melting pattern confirms the heat losses at part 3 because of very similar profiles. ⚠

- ⑤ Metallic ventilation tubes appear to be at a very low temperature. However this is due to the reflection of the clouds at 0 C (altitude 2600 ft). ✓
